## **BUILDING ENGINEERING**

### **FINAL DEGREE THESIS**

# **PLATFORM FOR FACADES DURABILITY ANALYSIS AND ITS IMPLEMENTATION IN OLSZTYN, POLAND**

**Student:** Aleix Sivera Calatayud

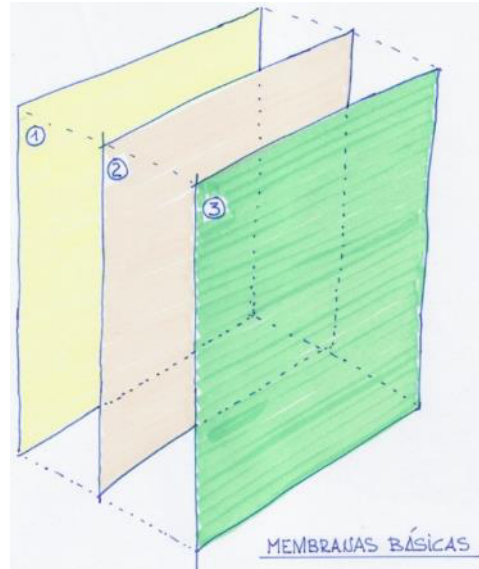
Figure 3.1a: Diagram of three basic membranes Source: Gibert-Royano 2010

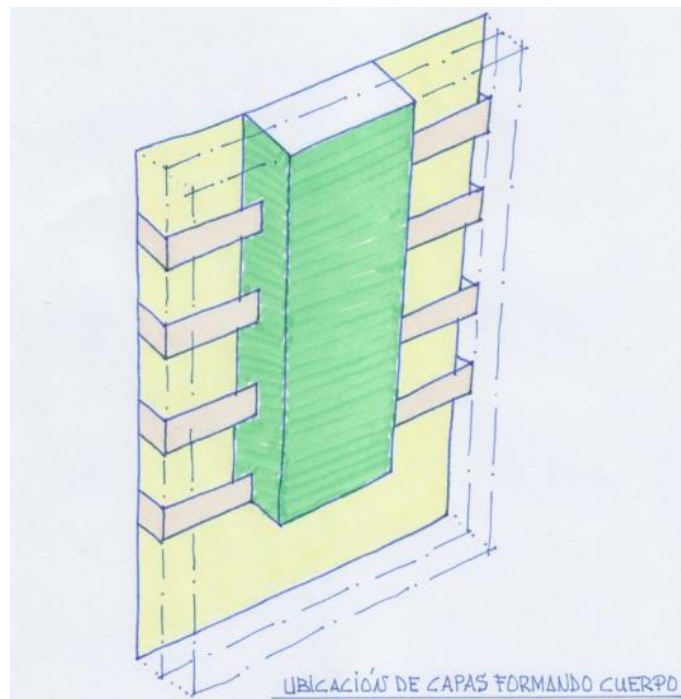
Figure 3.1b: Location of the layers that form the body Source: Gibert-Royano 2010

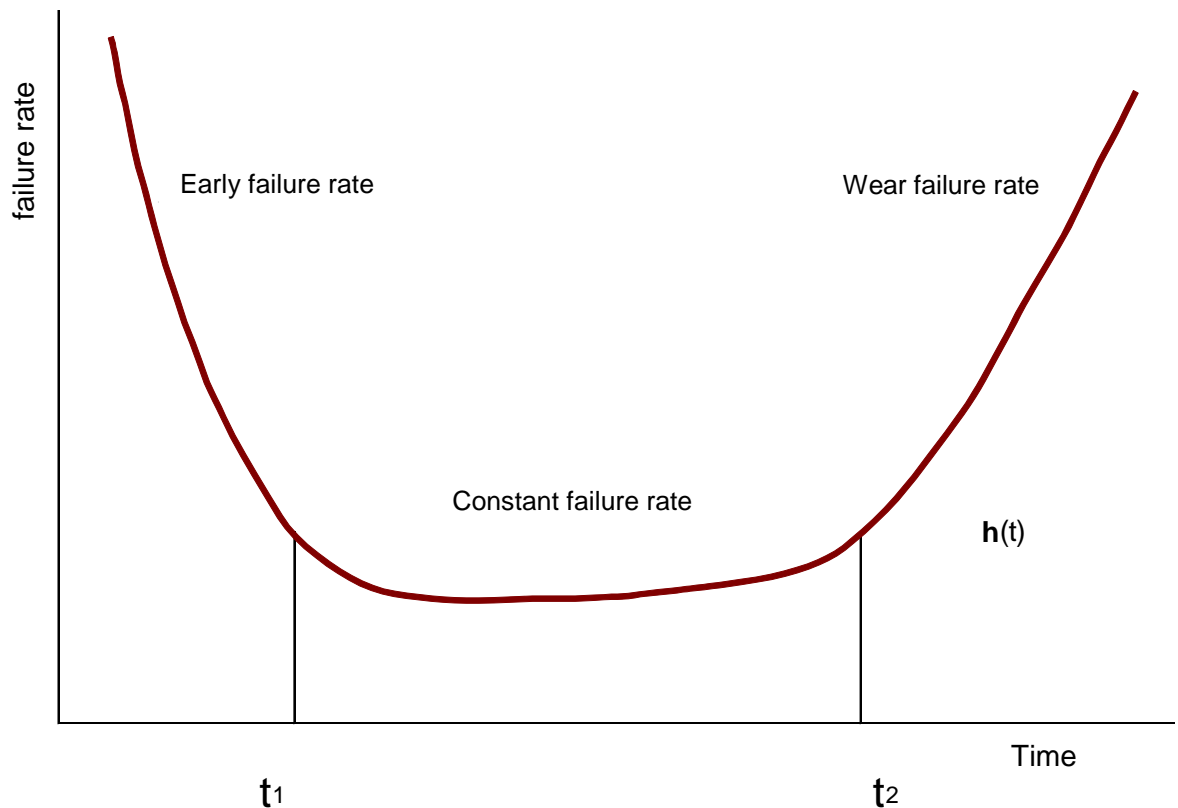
This segmentation can be illustrated with a graph of the hazard function  $h(t)$  of an ideal product, in which the three periods have comparable durations and take place in the order described above in Figure 4.1. This graph is called bathtub curve.

Figure 4.1: Bathtub curve Source: Gibert-Royano 2010.

The graph of the hazard function significantly presents the theoretical "bathtub curve" previously discussed. The risk of suffering the injury in one of the three severities is similar in all sections, although it is more common to suffer a low severity injury at the beginning of the life of the building and, instead, at the end of the analysis indicates that it is more likely to suffer it in medium severity.

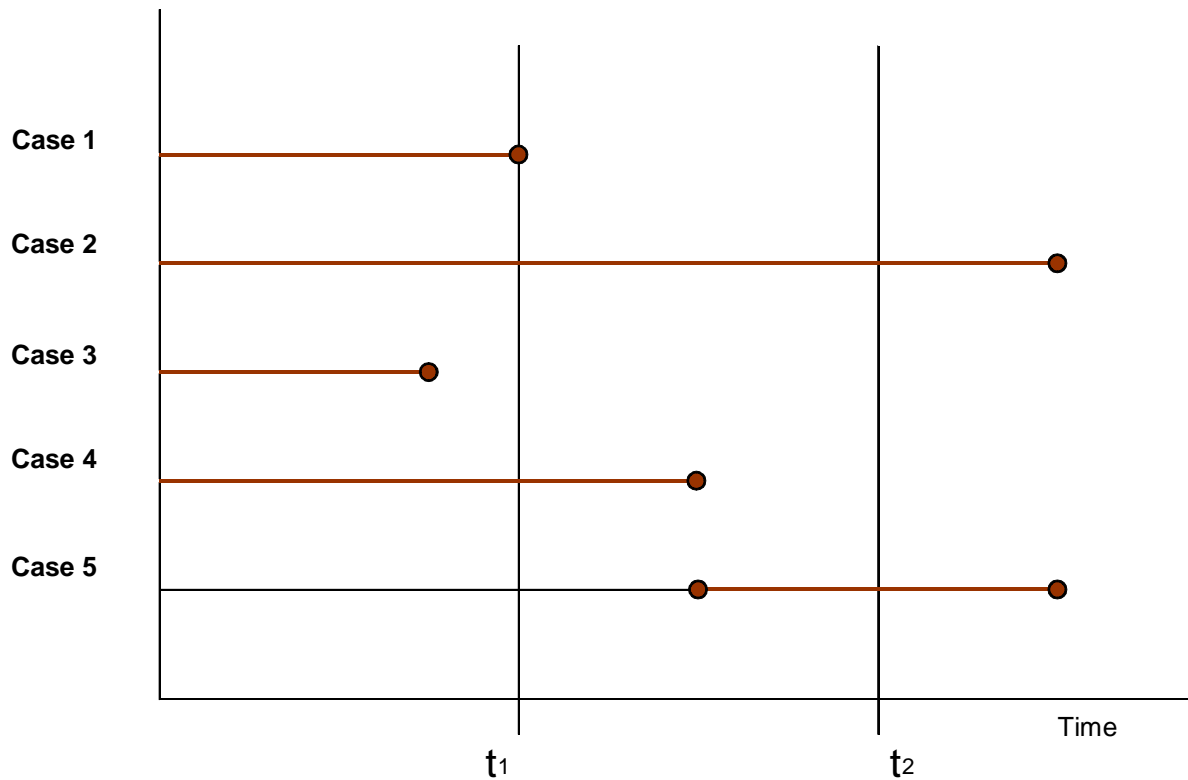
On the *Figure 4.2 Summary of the types of censorship in the data*, five cases with different failure observations are displayed, based on two different time moments and which kind of censorship corresponds to each one.

Figure 4.2: Summary of the types of censorship in the data Source: Gibert-Royano 2010

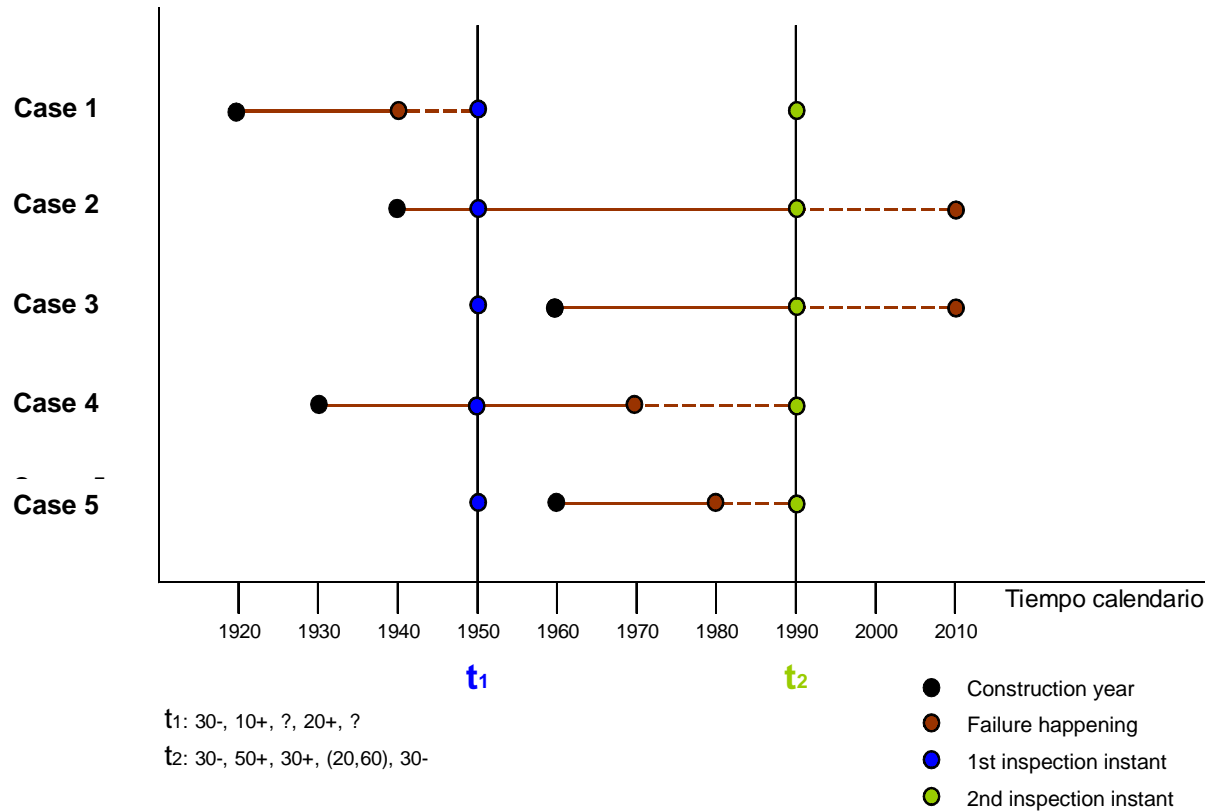
To further illustrate the concept of censorship applied to the building, in *Figure 4.3* are represented 5 new different cases in which is situated the year of construction of the facade and the two moments when the inspection of checking failures is performed ( $t_1=1950$  and  $t_2=1990$ ).

Figure 4.3: Types of censored data (scenario 1). Source: Gibert-Royano 2010

The hypothesis of these new results obtained provides censored information to estimate the probability of failure of the facades.

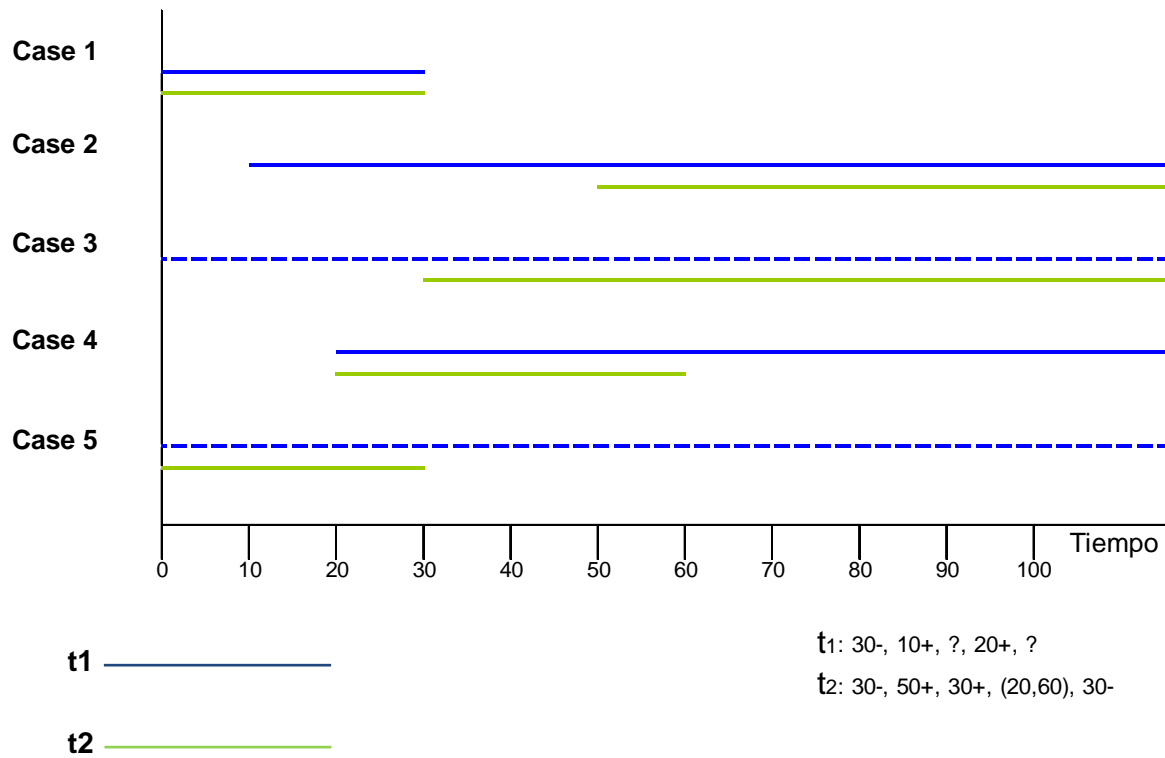
In this new scenario appear from time 0, two lines corresponding to the inspection times carried out and to the information provided for decision-making. This makes it possible to show a comparison between the data obtained from the inspection at time  $t_1$  against the performed at  $t_2$ .

Figure 4.4: Types of censored data (scenario 2)

The above results show that the realization of a second inspection improves, in most cases, the quality of the data obtained, being able to say that based on the studied sample, in the case 1 the failure will occurs before 30 years, in the case 2 after 50 years, in the case 3 after 30 years, in case 4 it failed between the 20 and 60 years, and in case 5 before 30 years.

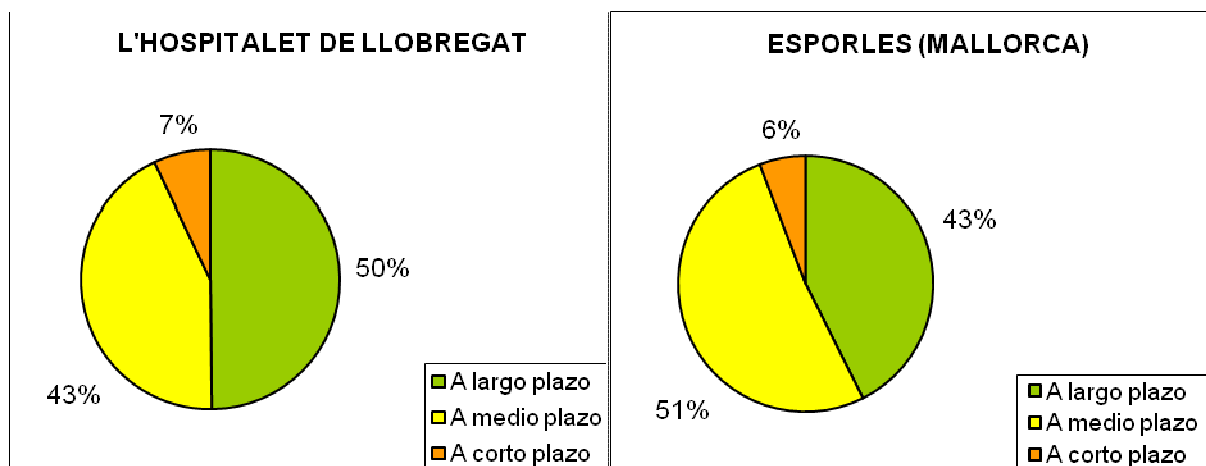
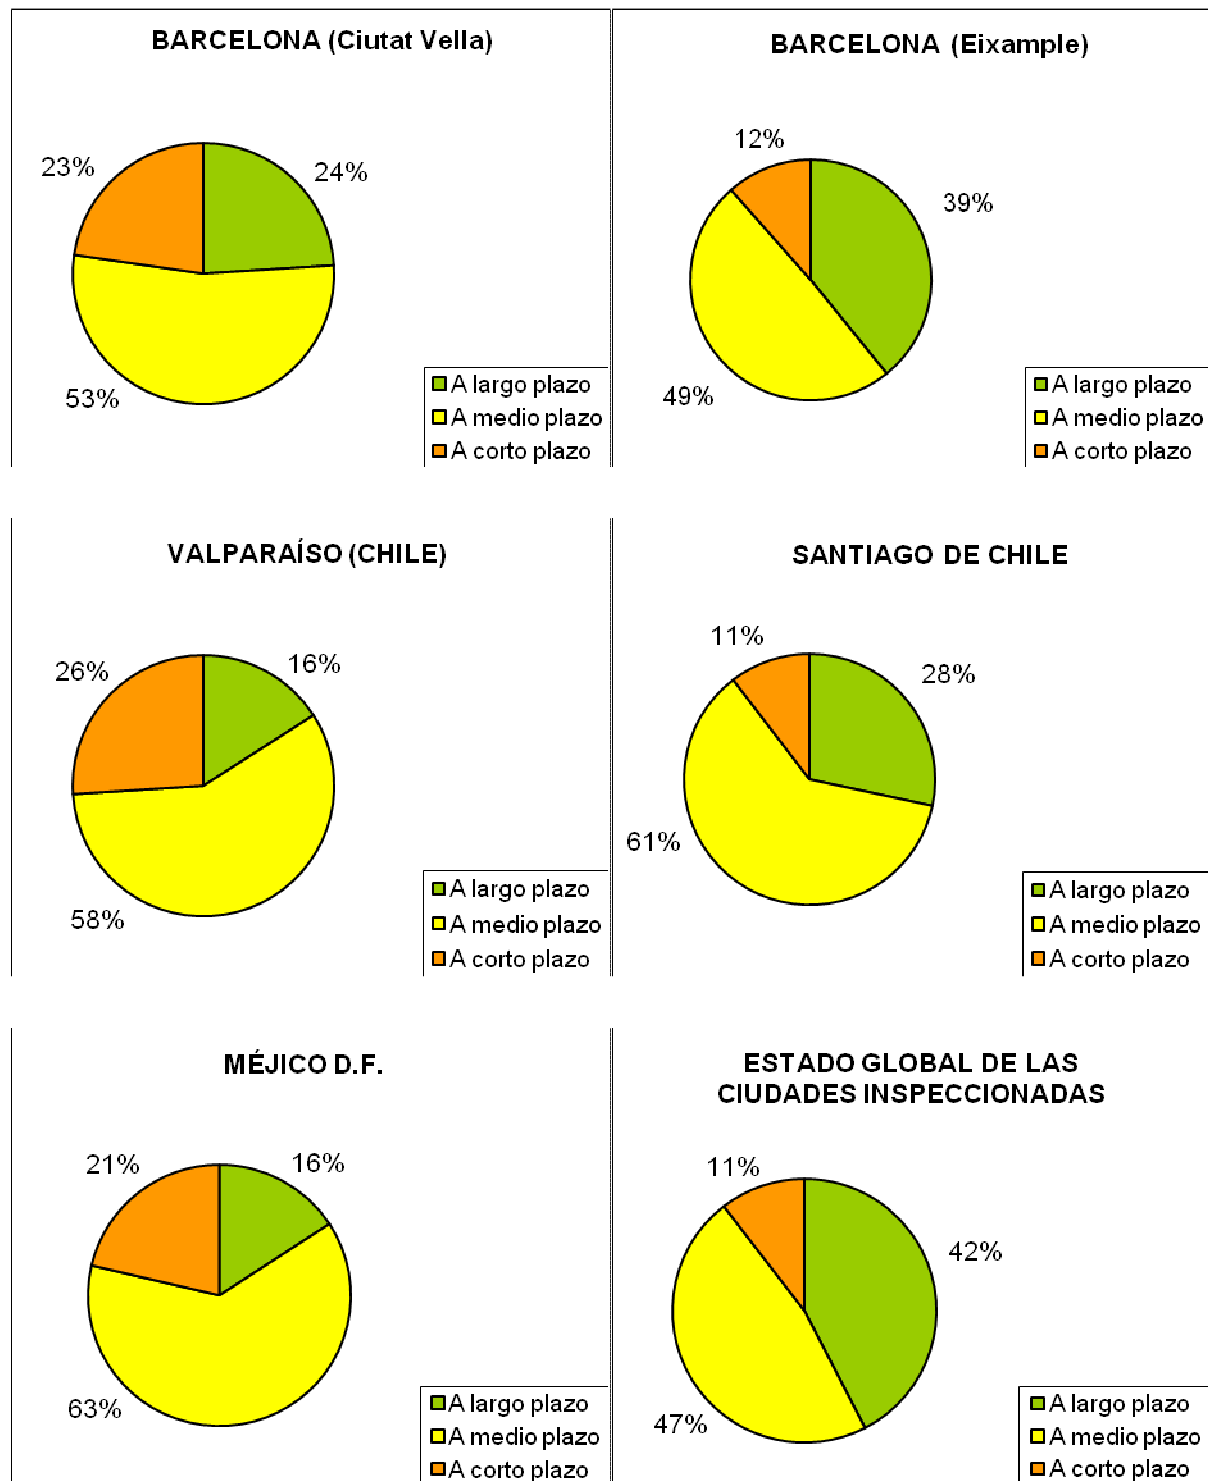
To establish more unified parameters regarding the decisions of action, have been grouped together the grades of severity of injuries represented in the tabs inspection 0-1-2 blocks for a proposed long-term performance, severities 3- 4 for the medium term, and 5-6 for short-term proposals. These severities have been linked to an equivalence in time of 10 years for long-term actions of 5-10 years for medium-term actions and finally to 1-5 years for short-term, except gravity 6 it has character immediately and must be removed within 24 to 48 hours. Figure 5.1 shows the percentage of our three divisions for each city and finally inspected the global status of all of them represented.

Figure 5.1: Percentages of the state of the facades and their intervention Adapted from: Gibert-Royano 2010

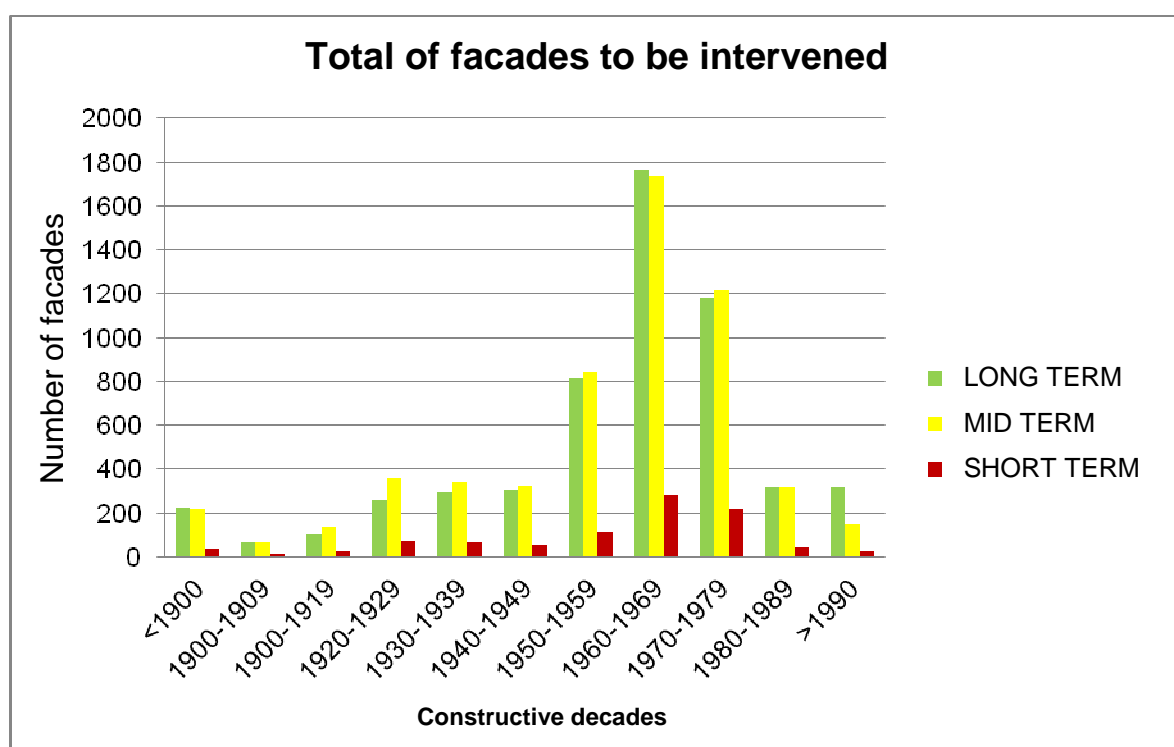
To evaluate in a global way the *Table 5.3* it has been created *Figure 5.4* which summarizes all the information extracted from other tables in Annex Band that reflects the percentage of injury by severity, translated into actions to adapt long, medium and short term of the entire city.

Figure 5.3: Summary graphic of l'Hospitalet de Llobregat Source: Gibert-Royano 2010

This study shows that the age of construction does not seem to be a single factor decisive for the poor condition in which the facades are, as in all decades appear very similar percentages in terms of their degradation. It should be noted the period of the years between the decades 50-60-70 as most critical for the large number of built facades. However, this situation decreases from the 80.

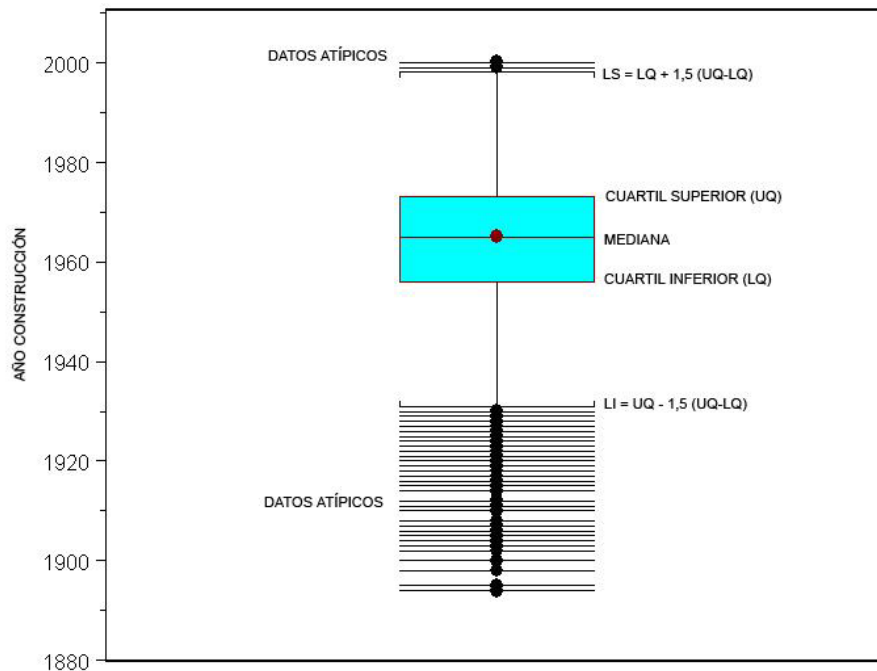
Figure 5.4 Boxplot by year of construction without outliers of the city Hospitalet de Llobregat Source: Gibert-Royano 2010

From the graph in Figure 5.6 is determined that the median age of building facades is set in the year 1965 and therefore sufficient time for the process of injury to be effective.

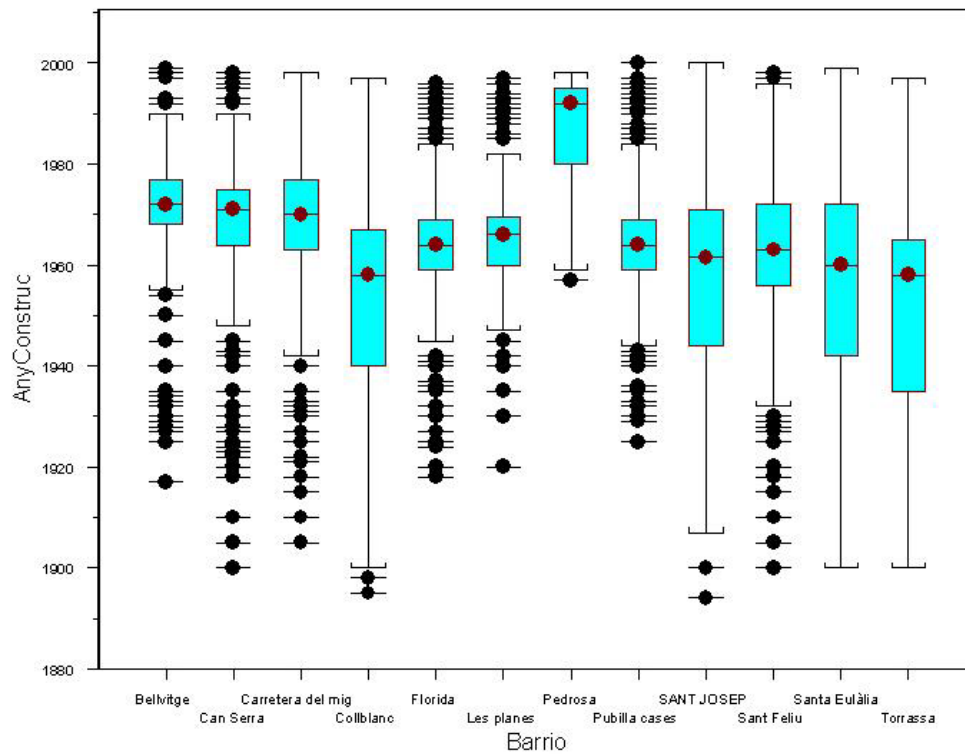
Figure 5.5 Boxplot by construction year without outliers for each neighbourhood of the city. Source: Gibert-Royano 2010

This new distribution by neighborhoods also shows sufficient homogeneity, as they all presented medians close to 1,965, highlighting the neighborhood Pedrosa with a lower median of 1.992 as the youngest neighborhood. Another situation is described in Collblanc, Santa Eulalia and Torrassa neighborhoods, whose medium is placed next to 1960, being the oldest and with a greater variability.

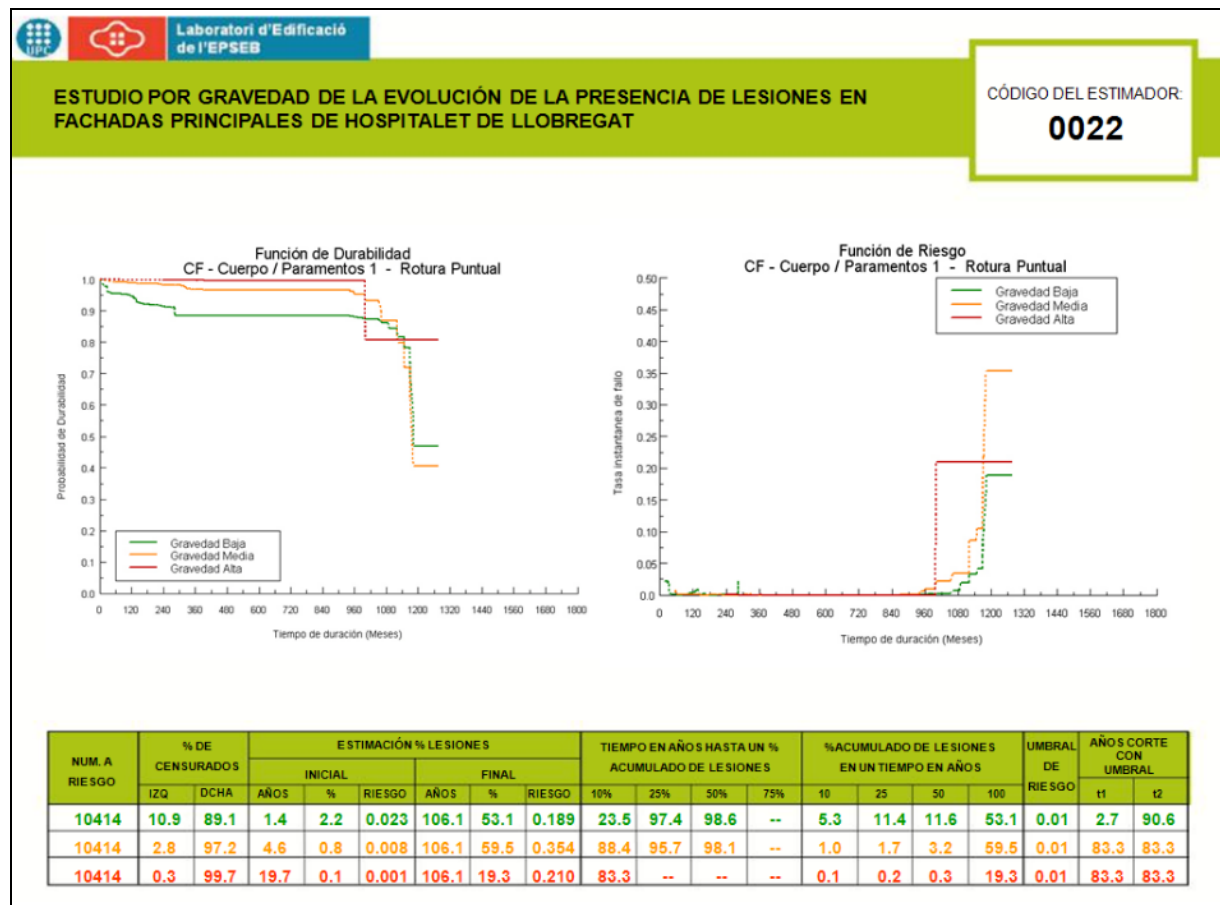
In order to help in the understanding of the data, the sheets are structured into three distinct zones: an upper zone in which the header is positioned to identify the type of study to be performed and the code estimator analyzed, an area formed by the central charts where estimates for the durability and hazard analysis are shown, and at the bottom in the summary table that associates the numeric data that is collected.

Figure 5.6: Sheet of evolution of the injuries depending of its severity (estimator 0022) Source: Gibert-Royano 2010

The charts show the levels of magnitude or severity, depending on the case analyzed with three different colors. For this project, the green line corresponds to an injury with punctual magnitude or low severity, the orange line corresponds to a lesion with local magnitude or medium severity, and the red line corresponds to a lesion with a general magnitude or high severity, although not necessarily for all the elements studied it has been able to estimate the three magnitudes or severities.

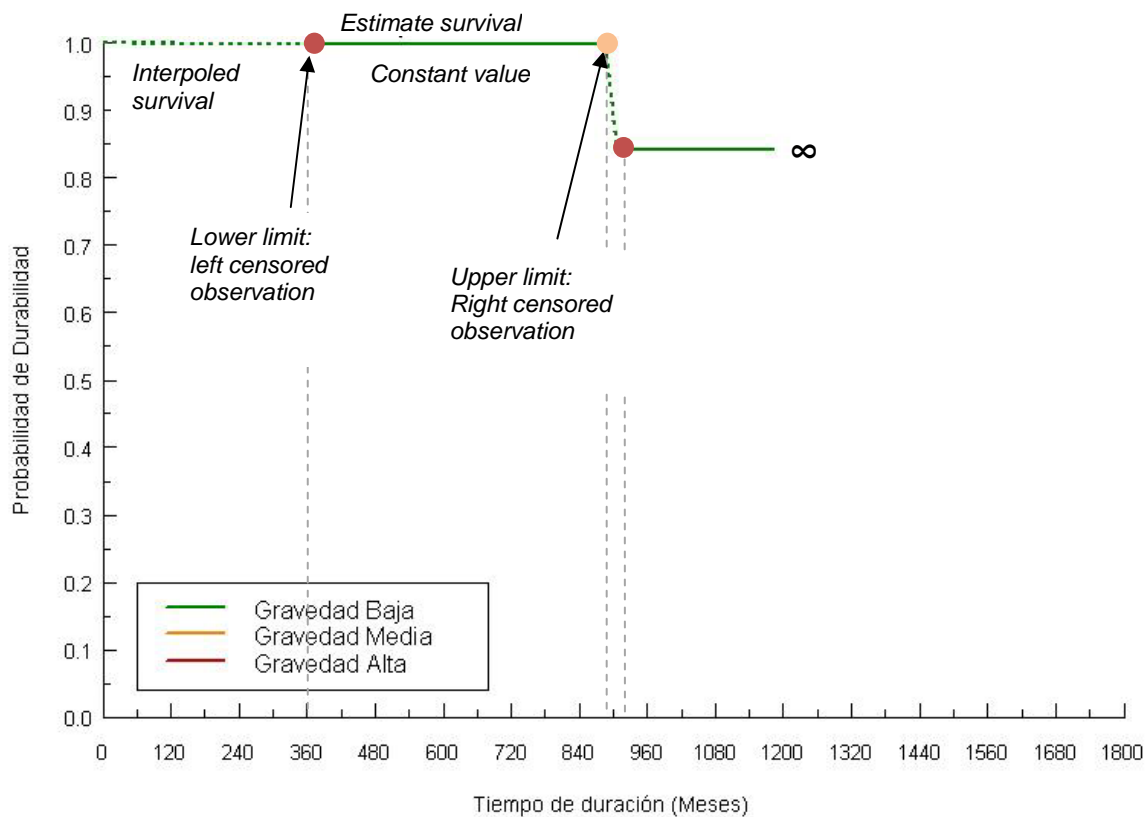
As mentioned in Chapter IV - *Proposed reliability analysis techniques in the building*, the graphics are formed by solid and dashed lines that set the time intervals estimated. These ranges have as their lower limit an observation censored by the left and as the upper limit the right censored observation (previous to the next left censored). To make possible for the Turnbull estimator estimate the durability in two time intervals, we must have at least two left censored observations in the dataset. The number of falls or durability variations is greater when higher the number of failures or left censored times in a row. The last durability estimated range has as upper limit the last right censored time. Figure 5.9 describes the concepts explained through the analysis of a real graph.

Figure 5.7: Durability function analysis. Source: Gibert-Royano 2010

In the lower part of the tab is found the Table 5.6 which is composed by an equal header for all cases, and three lower rows which show the three levels of magnitude or severity identified with the same color as shown in the graphs.

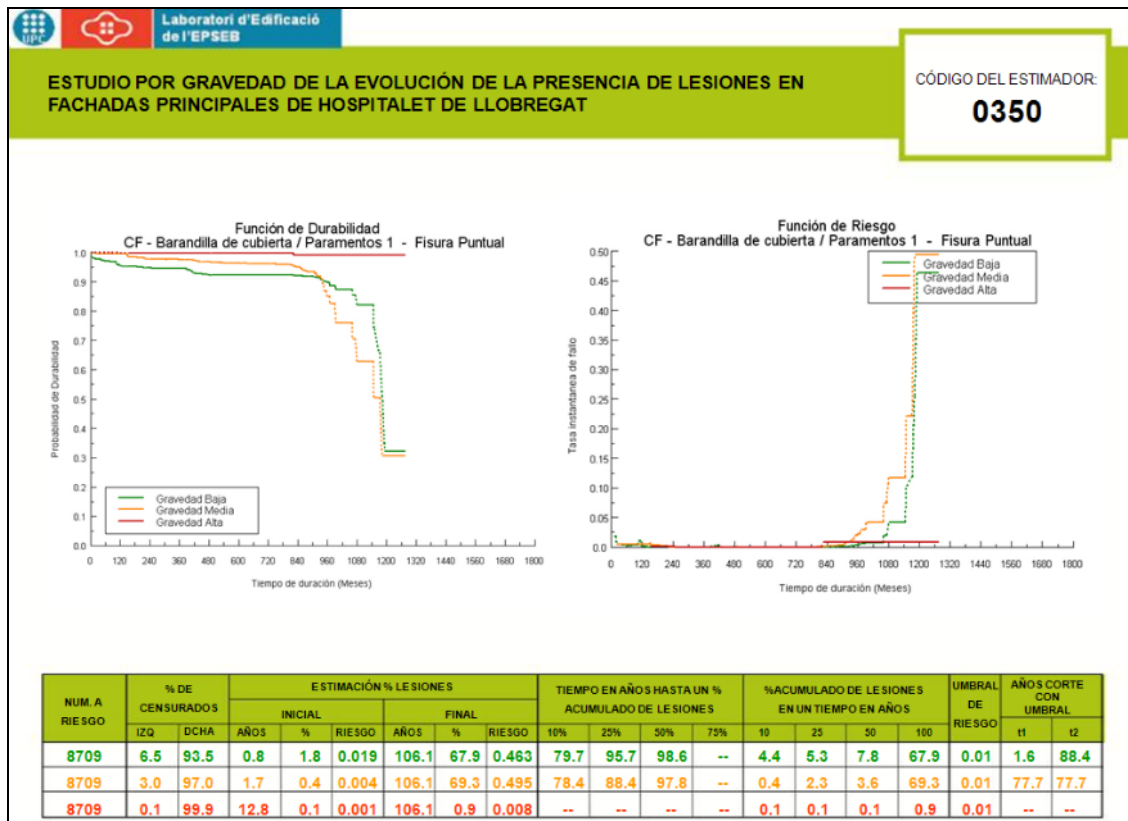
Figure 5.8: Sheet of injuries depending on its severity evolution (estimator 0350). Source: Gibert-Royano 2010

The sheet of injuries evolution corresponding to Figure 5.10 shows that the percentage of left-censored data differs for the three levels. To the low severity it is corresponded a 6.5%, while the medium severity a 3.0% and the 0.1% for the high severity. In the same sheet is found that the individuals at risk are 8,709, ie there are 8,709 facades with plastered coating of the 10,041 total constituting the sample of l'Hospitalet de Llobregat. According to the state of preservation found in the inspection of 8,709 facades,, there is 6.5%, which is equivalent to 567 facades, in low severity; 3.0%, equivalent to 262 facades, in medium severity; and 0.1%, corresponding to 88 facades, for the high severity.

From the analysis of the three lines representing the three estimated severities, the similarity between progression of low and medium severities is extracted. Shown how, with the passage of time, are estimated the lowest durabilities. Note the scarce presence of injuries with a high severity, which even prevents the estimation of the first decile; similarly, the estimating only of 0.9% of these injuries after 100 years.

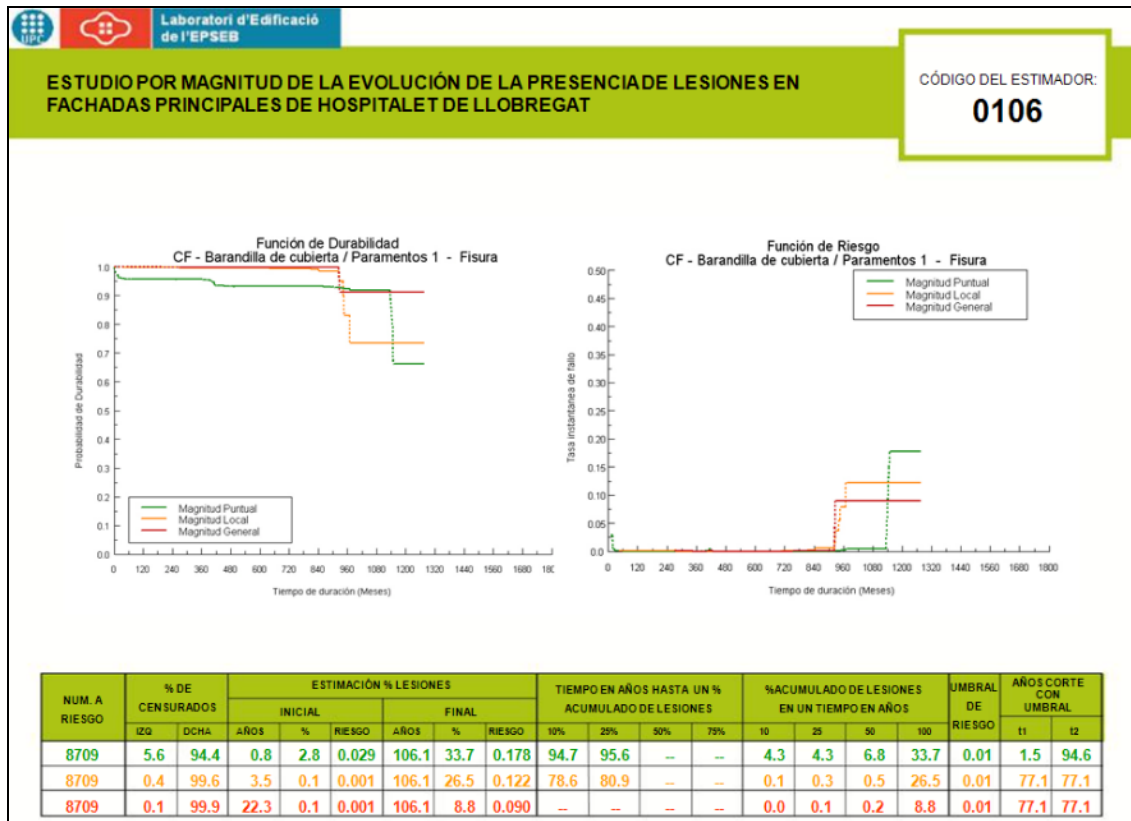
Figure 5.9 Sheet of evolution of the injuries depending on their magnitude (estimator 0106). Source: Gibert-Royano 2010

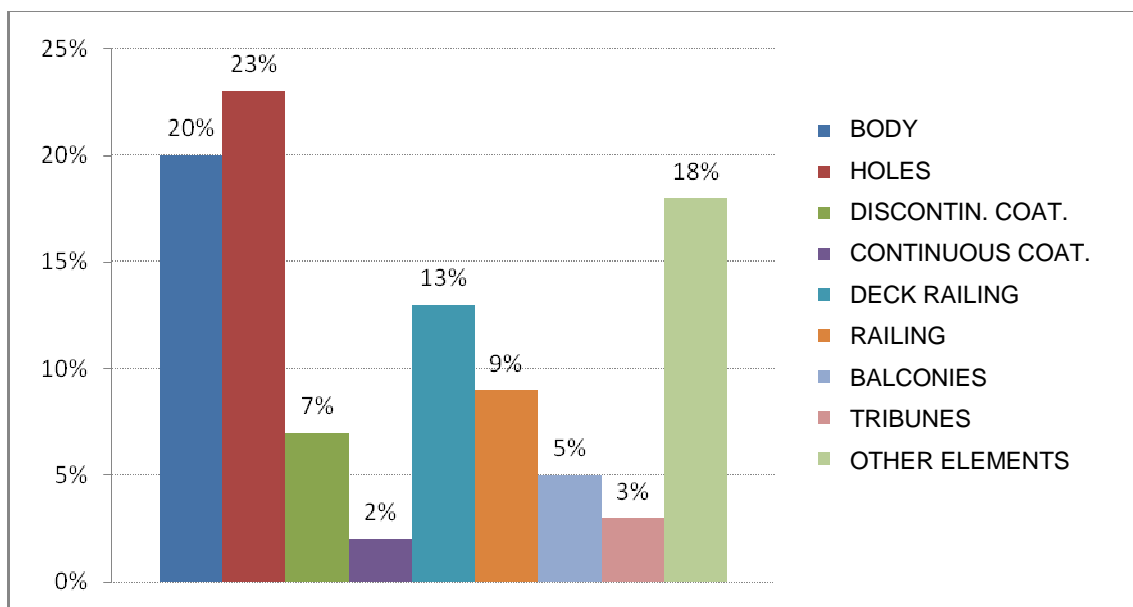
In the *Figure 5.12* it is introduced a bar graph in which the percentage of injuries on different facades of the building elements are displayed, compared to the total of found lesions (47,302).

Figure 5.10: Percentage of injuries in the different constructive elements in the facades Source: Gibert-Royano 2010

The results show that the elements that suffer the most injuries are those located in the holes of the facades with 23%, followed by the body of the facade with 20%. The elements that have fewer injuries are the continuous coatings and the tribunes, with 2% and 3% respectively.

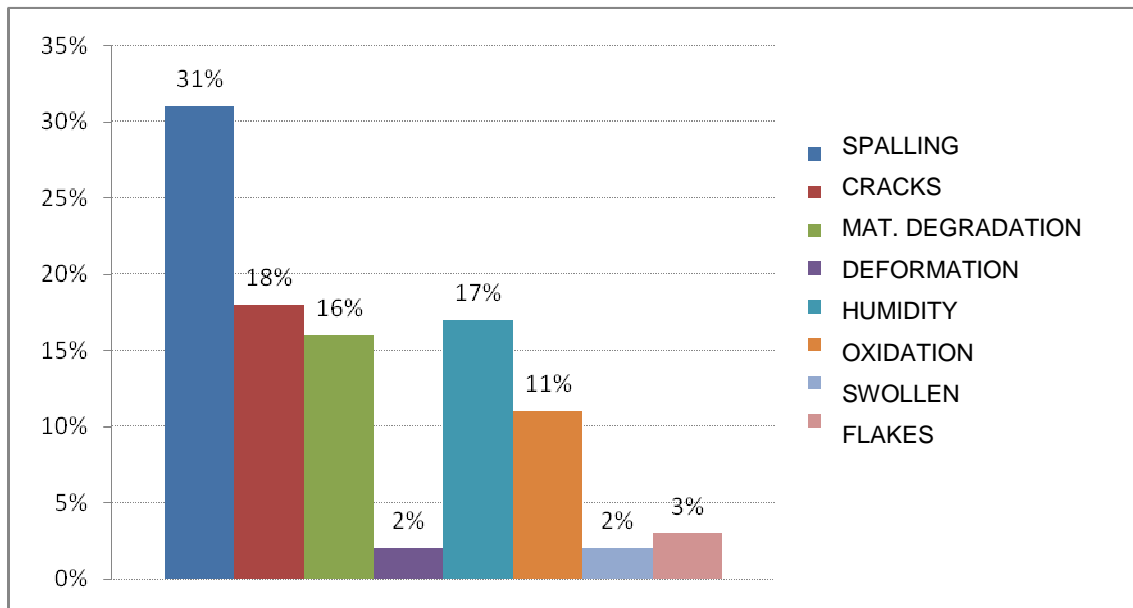
In *Figure 5.13* one can see the percentage of impact on the various injuries.

*Figure 5.11: Percentage of affection of the different injuries Source: Gibert-Royano 2010*

In the results obtained, we must highlight the break as the most common injury with 31%, while the addition of deformation, swollen and flakes represents only 7% of the total.

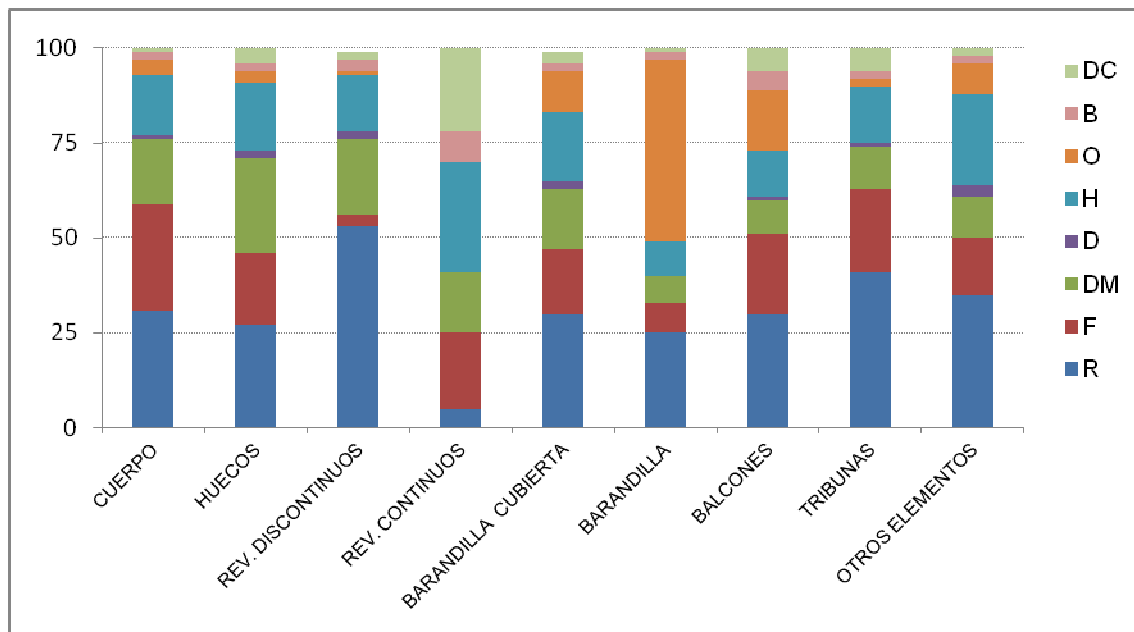
Figure 5.14 stratifies the impact of different injuries for each of the constructive elements of the facades, so it is possible to determine the influence of each lesion on the total of found lesions in a given element.

Figure 5.12: Accumulative percentages of injuries in the different elements Source: Gibert-Royano 2010

The most relevant data are located on one side in discontinuous coatings, which have about 50% of their injuries focused on breaks and, secondly, on the railings, where we found the same percentage of lesions because of oxidations. From these results the following reflection arises: to increase the lifetime of the facades is necessary to pay special attention to the quality and type of materials and the implementation process as well as carry out a plan of timed maintenance. The high percentage of cracks in the tiling may be due to the poor quality of the material or incorrect execution method. In the case of oxidation on the railings, it is likely that has not been protected properly or has not been made sufficiently planned preventative maintenance.

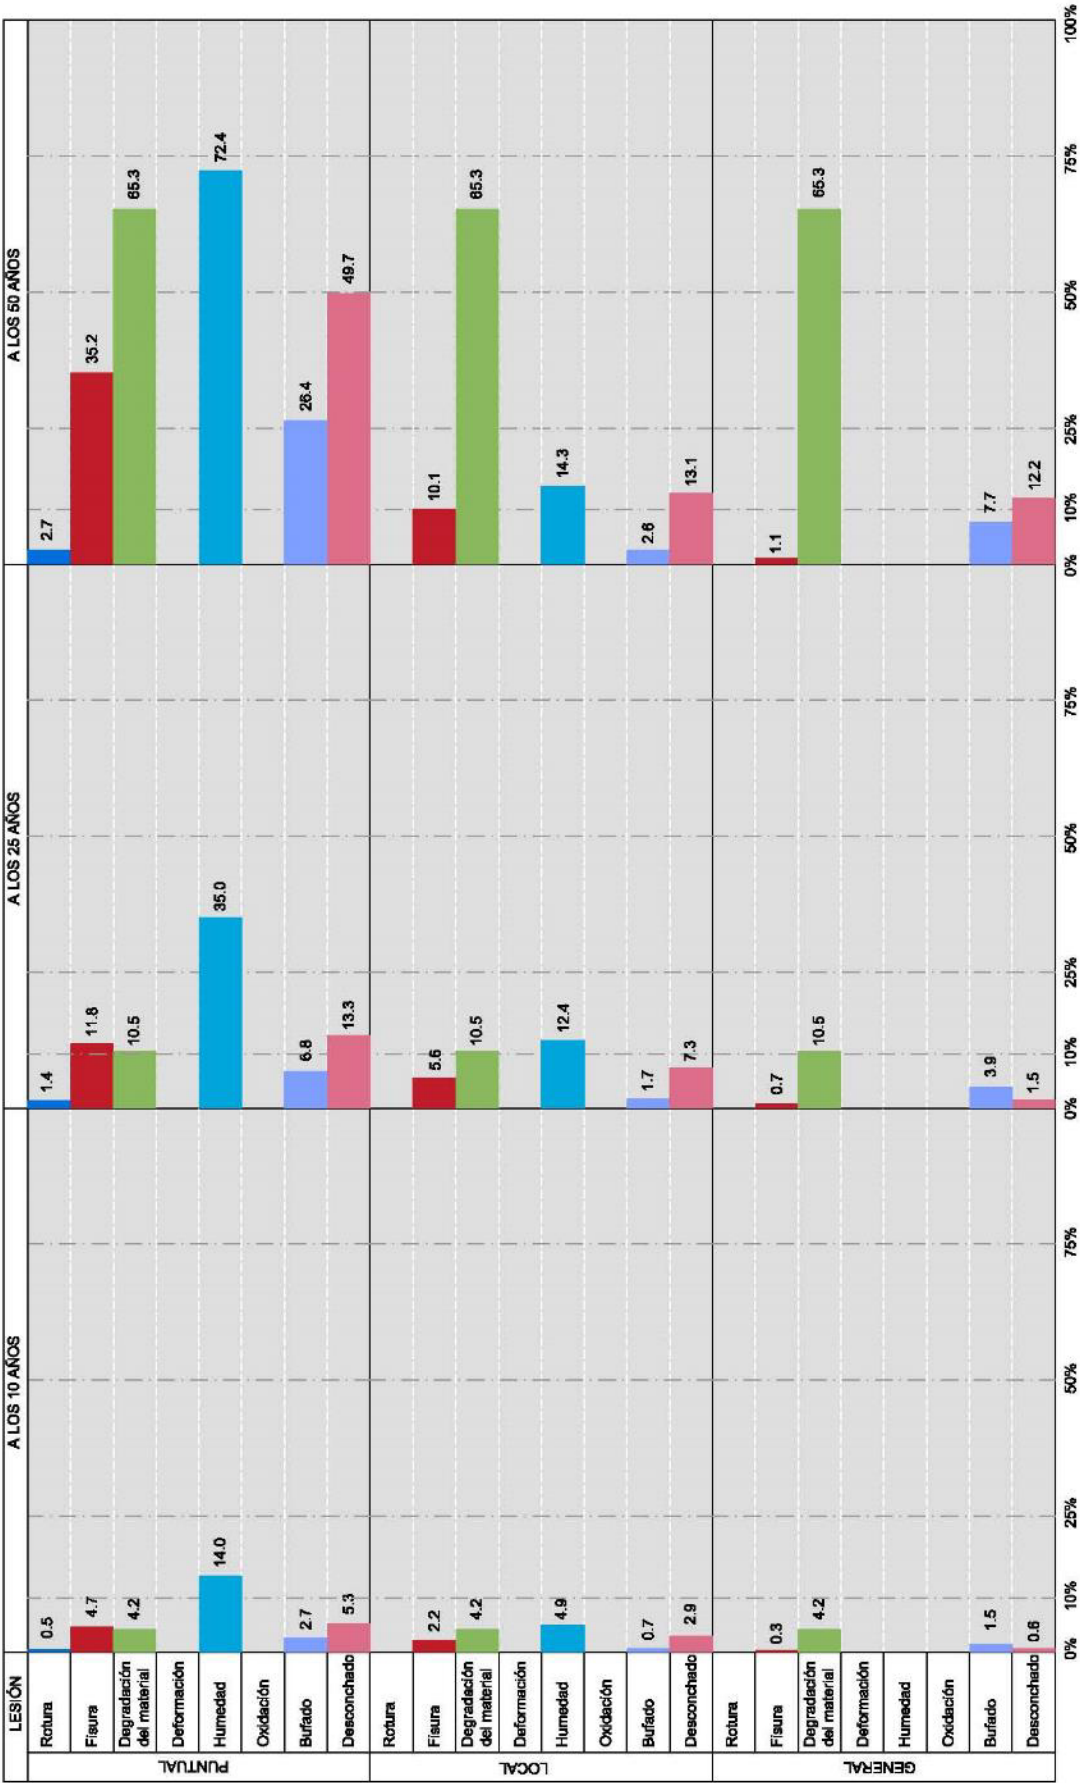
Figure 5.13: Percentages of injuries at a certain time. Source: Gibert-Royano 2010

If to introduce corrective actions we estimate that 10% involvement is the warning threshold, it would be thought that all those lesions that exceed this percentage would trigger the alarms to proceed to intervene the facades. In the studied case, to avoid the appearance of this percentage of injury in cracks, material degradation, flaking and moisture, should have been created corrective measures before the 25 year life of the building. If these measures are carried out appears another reality which is what stands out in the percentage jump between 25 and 50 years, a period in which this development is very significant in humidity, material degradation, chips and cracks as well in swollen and, although the latter are shown in a lesser extent.

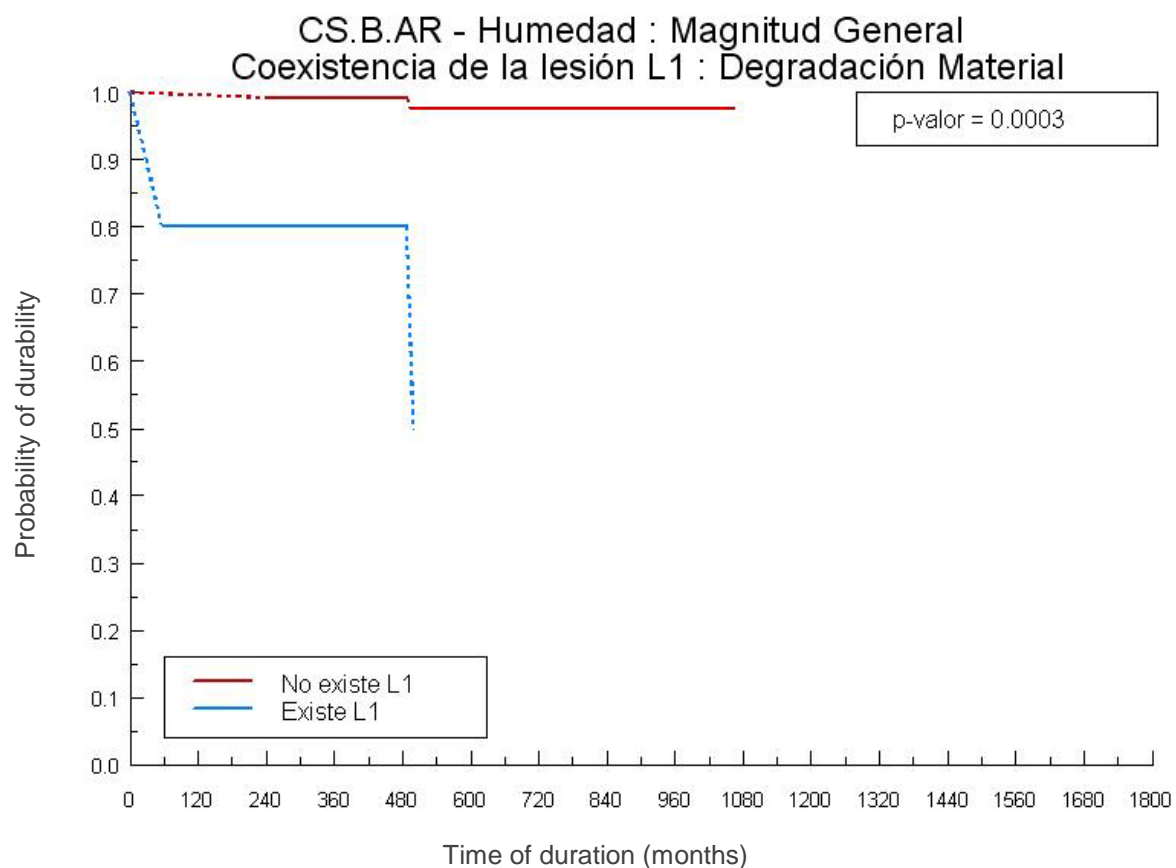
To determine the existence or not of significant differences between the resulting non-parametric distributions, we used the proposed test by Gomez et al. (2004). The p-value, as illustrated in Figure 5.16, appears as a legend in the graph so that the user can obtain conclusions about whether or not significant differences exist between the two graphs from a certain confidence level. The significance level is obtained by subtracting to 1 the established confidence level. For example, if the user chooses to analyze charts with a confidence level of 0.999 (99.9%), as is the case of this project, it is considered that there are significant differences between the different curves if the p-value associated the graphic is less than 0.001 ( $1 - 0.999 = 0.001$ ). In the field of statistics values most commonly used for the confidence level are 95%, 99% and 99.9%.

Figure 5.14: Chart of multivariate analysis by injuries coexistence Source: Gibert-Royano 2010

Looking ahead to the interpretation of results, must be taken into account, together with the p-value obtained, sample circumstances that may affect the magnitude of this statistic as: a low number of individuals at risk, a big difference between individuals a coexistence risk of injury and to the absence of the same, a loss of a large number of individuals at the start of estimation, etc. In cases where the number of inspected facades is very high (greater number of individuals at risk), all these factors have less influence. It is not the same to have a sample of 350 facades inspected which have 80 individuals at risk and at the beginning 60 fail, that have a sample of 12,000 facades in which they are 3,000 individuals at risk and at the beginning where 60 also fail. In this second case, the remaining sample remains significant compared to the total and the large number of individuals at risk allows not to be displayed anomalous behaviors, since the behavior of most individuals masks the atypical behavior of a few of them, which does not occur in the first case, where any anomalous behavior of some individuals is not compensated by the standard behavior of other individuals.
